TRAFFIC OPERATIONS STUDY:

15 LOCATIONS ON CAPE COD

CAPE COD PLANNING AND ECONOMIC

December 15, 1970

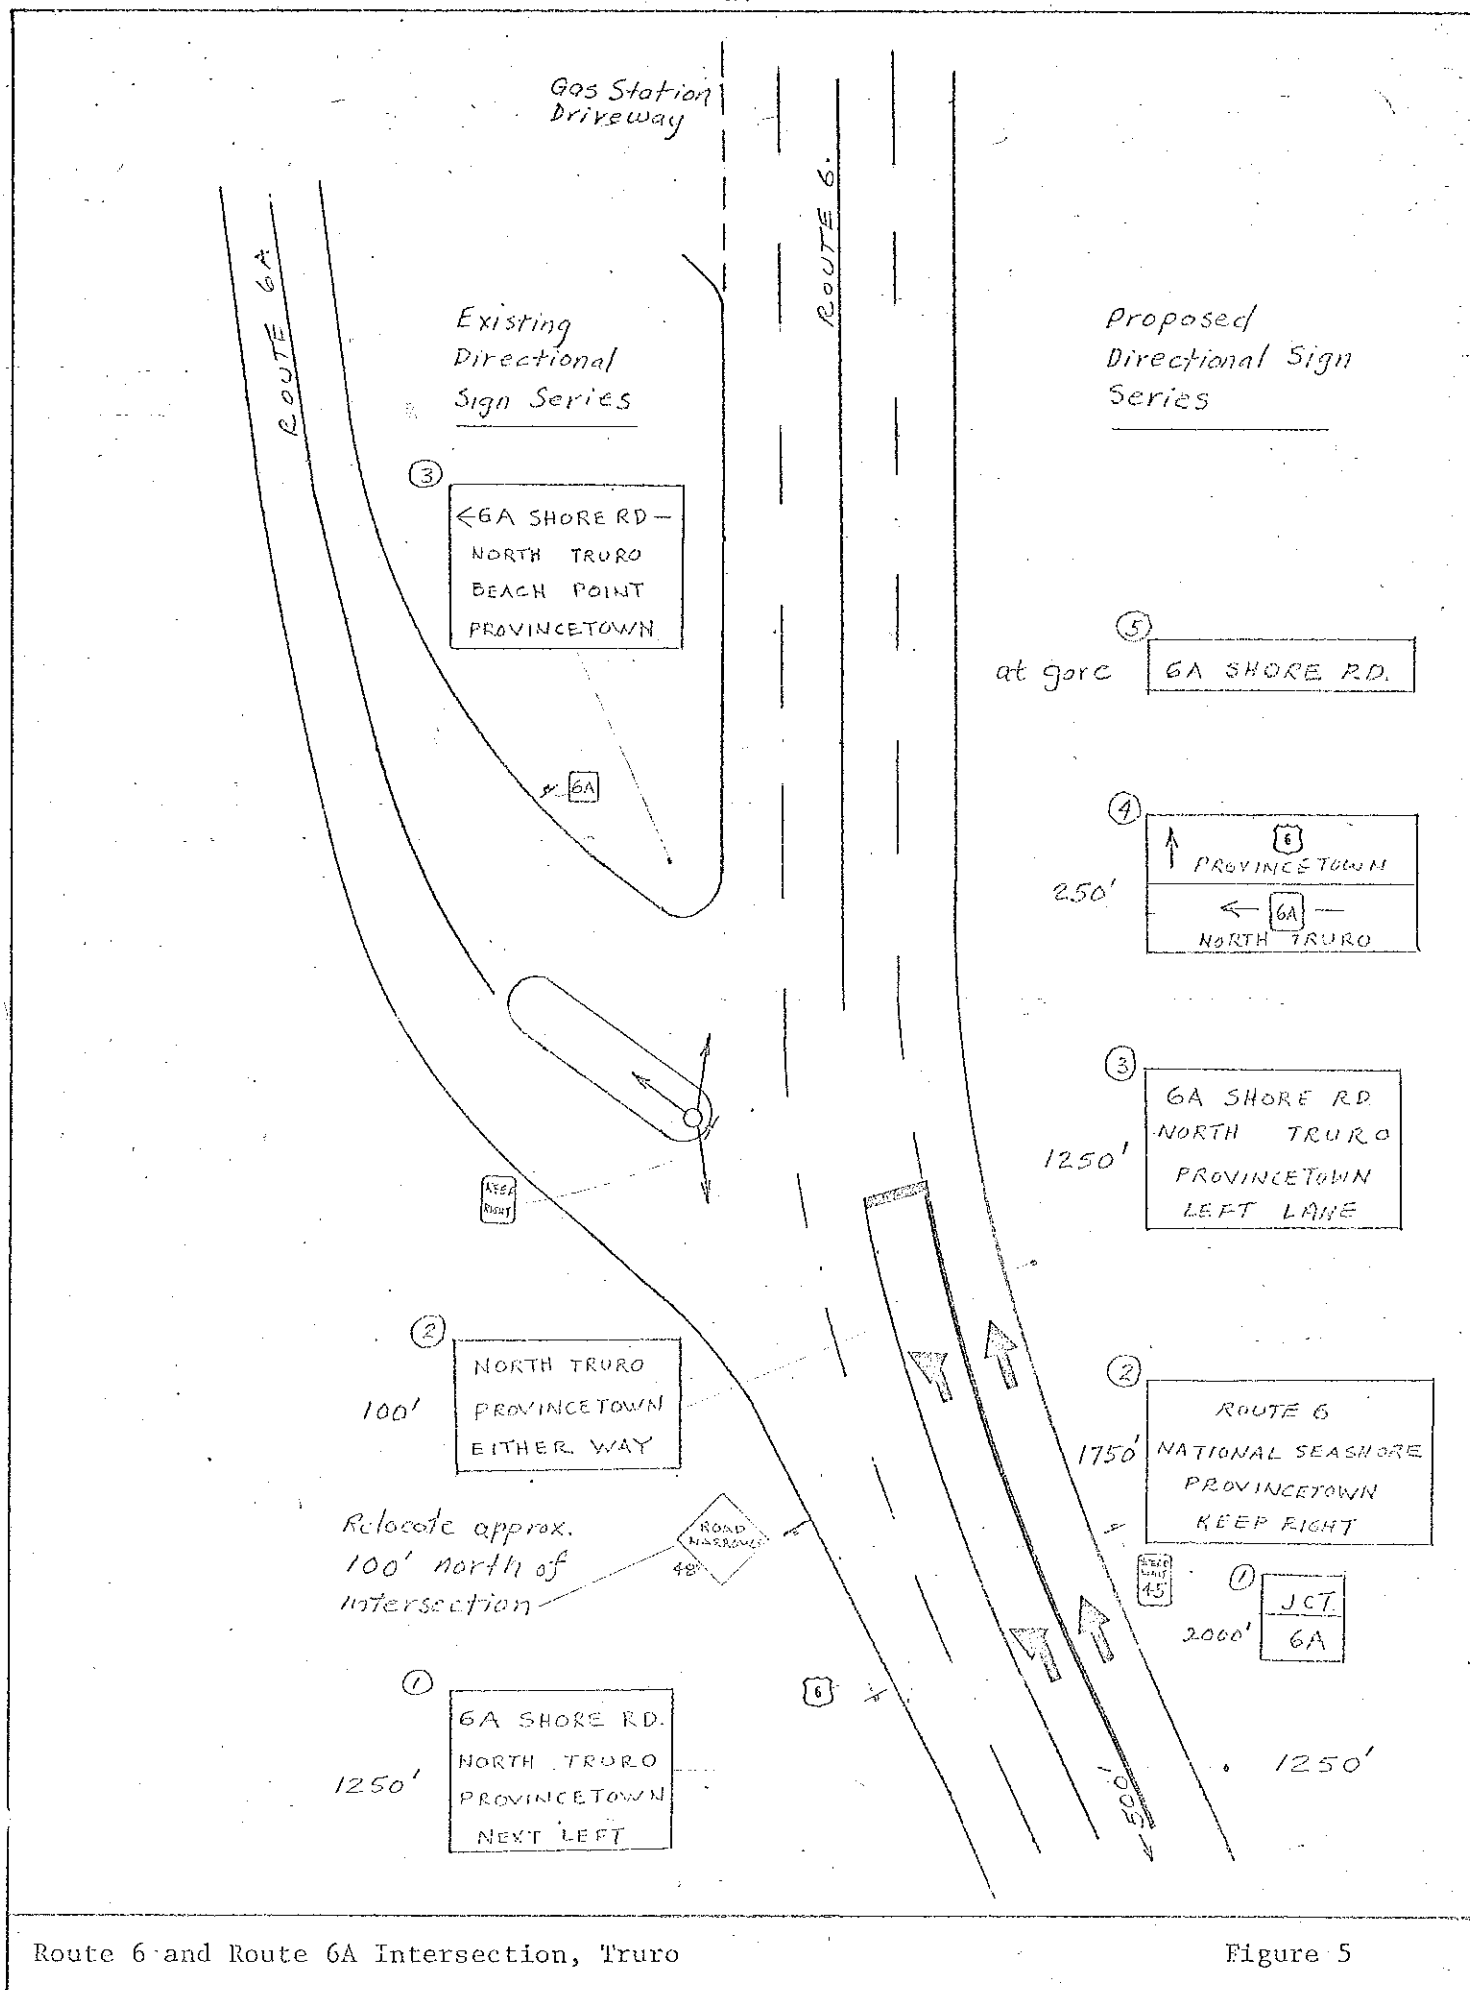
Figure 5

Route 6 and Route 6A Intersection, Truro

In order to alleviate the motorists' decision-making dilemma at this intersection, it is recommended that the northbound directional signs series be revised. (See Figure 5.) The sign located approximately 1,250 feet from the intersection which reads, "6A Shore Road, North Truro, Provincetown, Next Left," should be re-worded so that the bottom line reads "Left Lane." Prior to that, located at an appropriate distance, should be a new sign reading, "Route 6, Provincetown, National Seashore, Keep Right." The sign which now reads "North Truro Provincetown Either Way," which is located just at the intersection, should be replaced by a directional sign which shows "Provincetown" and "Truro" with arrows. The directional sign at the gore facing northbound which says "6A Shore Road, North Truro, Beach Point, Provincetown" should be replaced by a sign which merely says, "6A Shore Road."

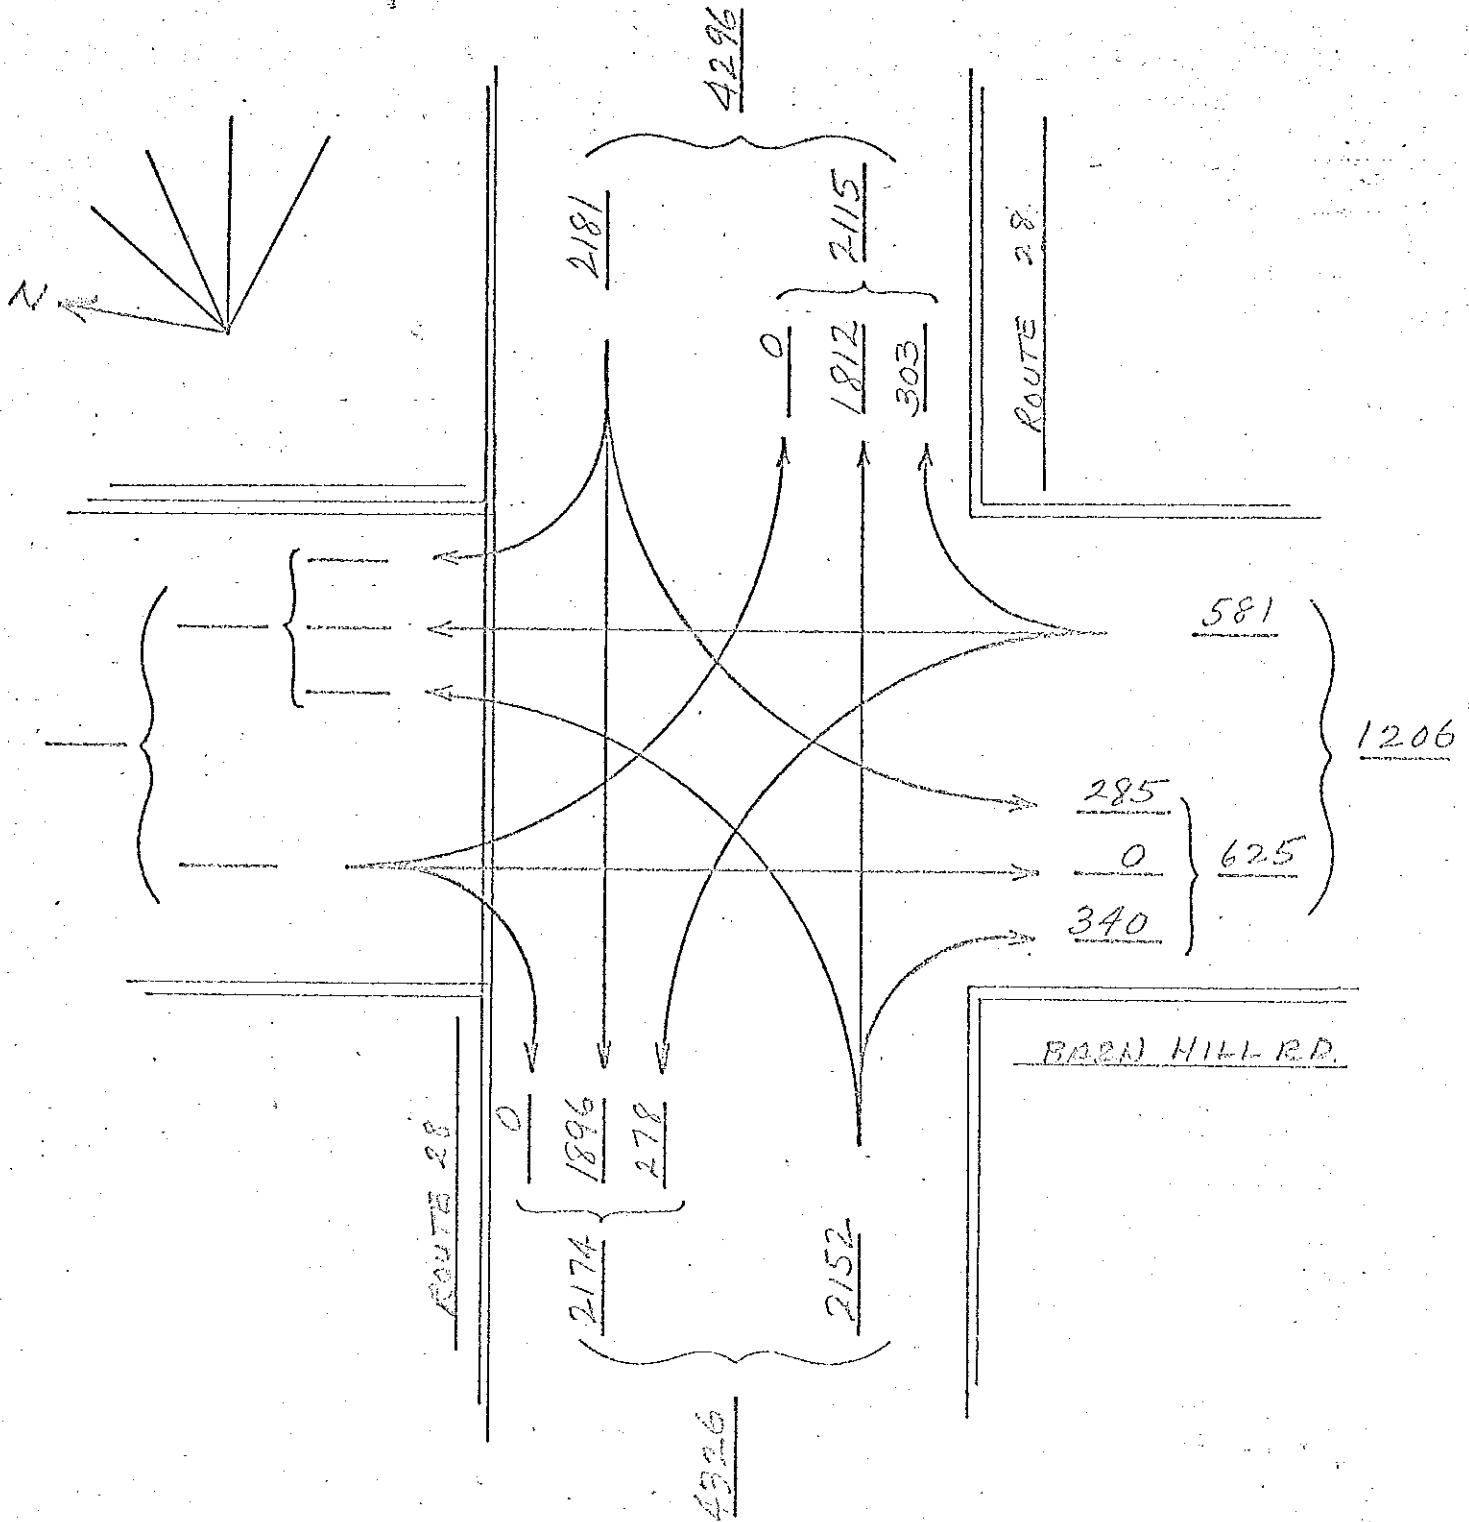
Figure 11

While Barn Hill Road serves a limited area, traffic volumes have increased because of increased parking capacity at a major traffic generator -- Harding Beach. Although land uses served by the road have not changed, their intensity has increased which has caused a direct increase in traffic volumes. Route 28 itself has a reputation for being crowded most of the summer, although this section of Route 28 is considerably less congested than in Yarmouth and Harwich. Much of the traffic volumes and the numerous delays are caused by extensive strip development with virtually no control of access. This situation gives rise to erratic traffic movements on Route 28. Improved access control would not reduce traffic volumes or traffic generation of abutting businesses, but would certainly improve traffic operations, including travel speed. This intersection area represents just one more obstacle for traffic on Route 28. For traffic on Barn Hill Road, it represents a challenge, particularly for those making a left turn westbound. (See Figure 11)

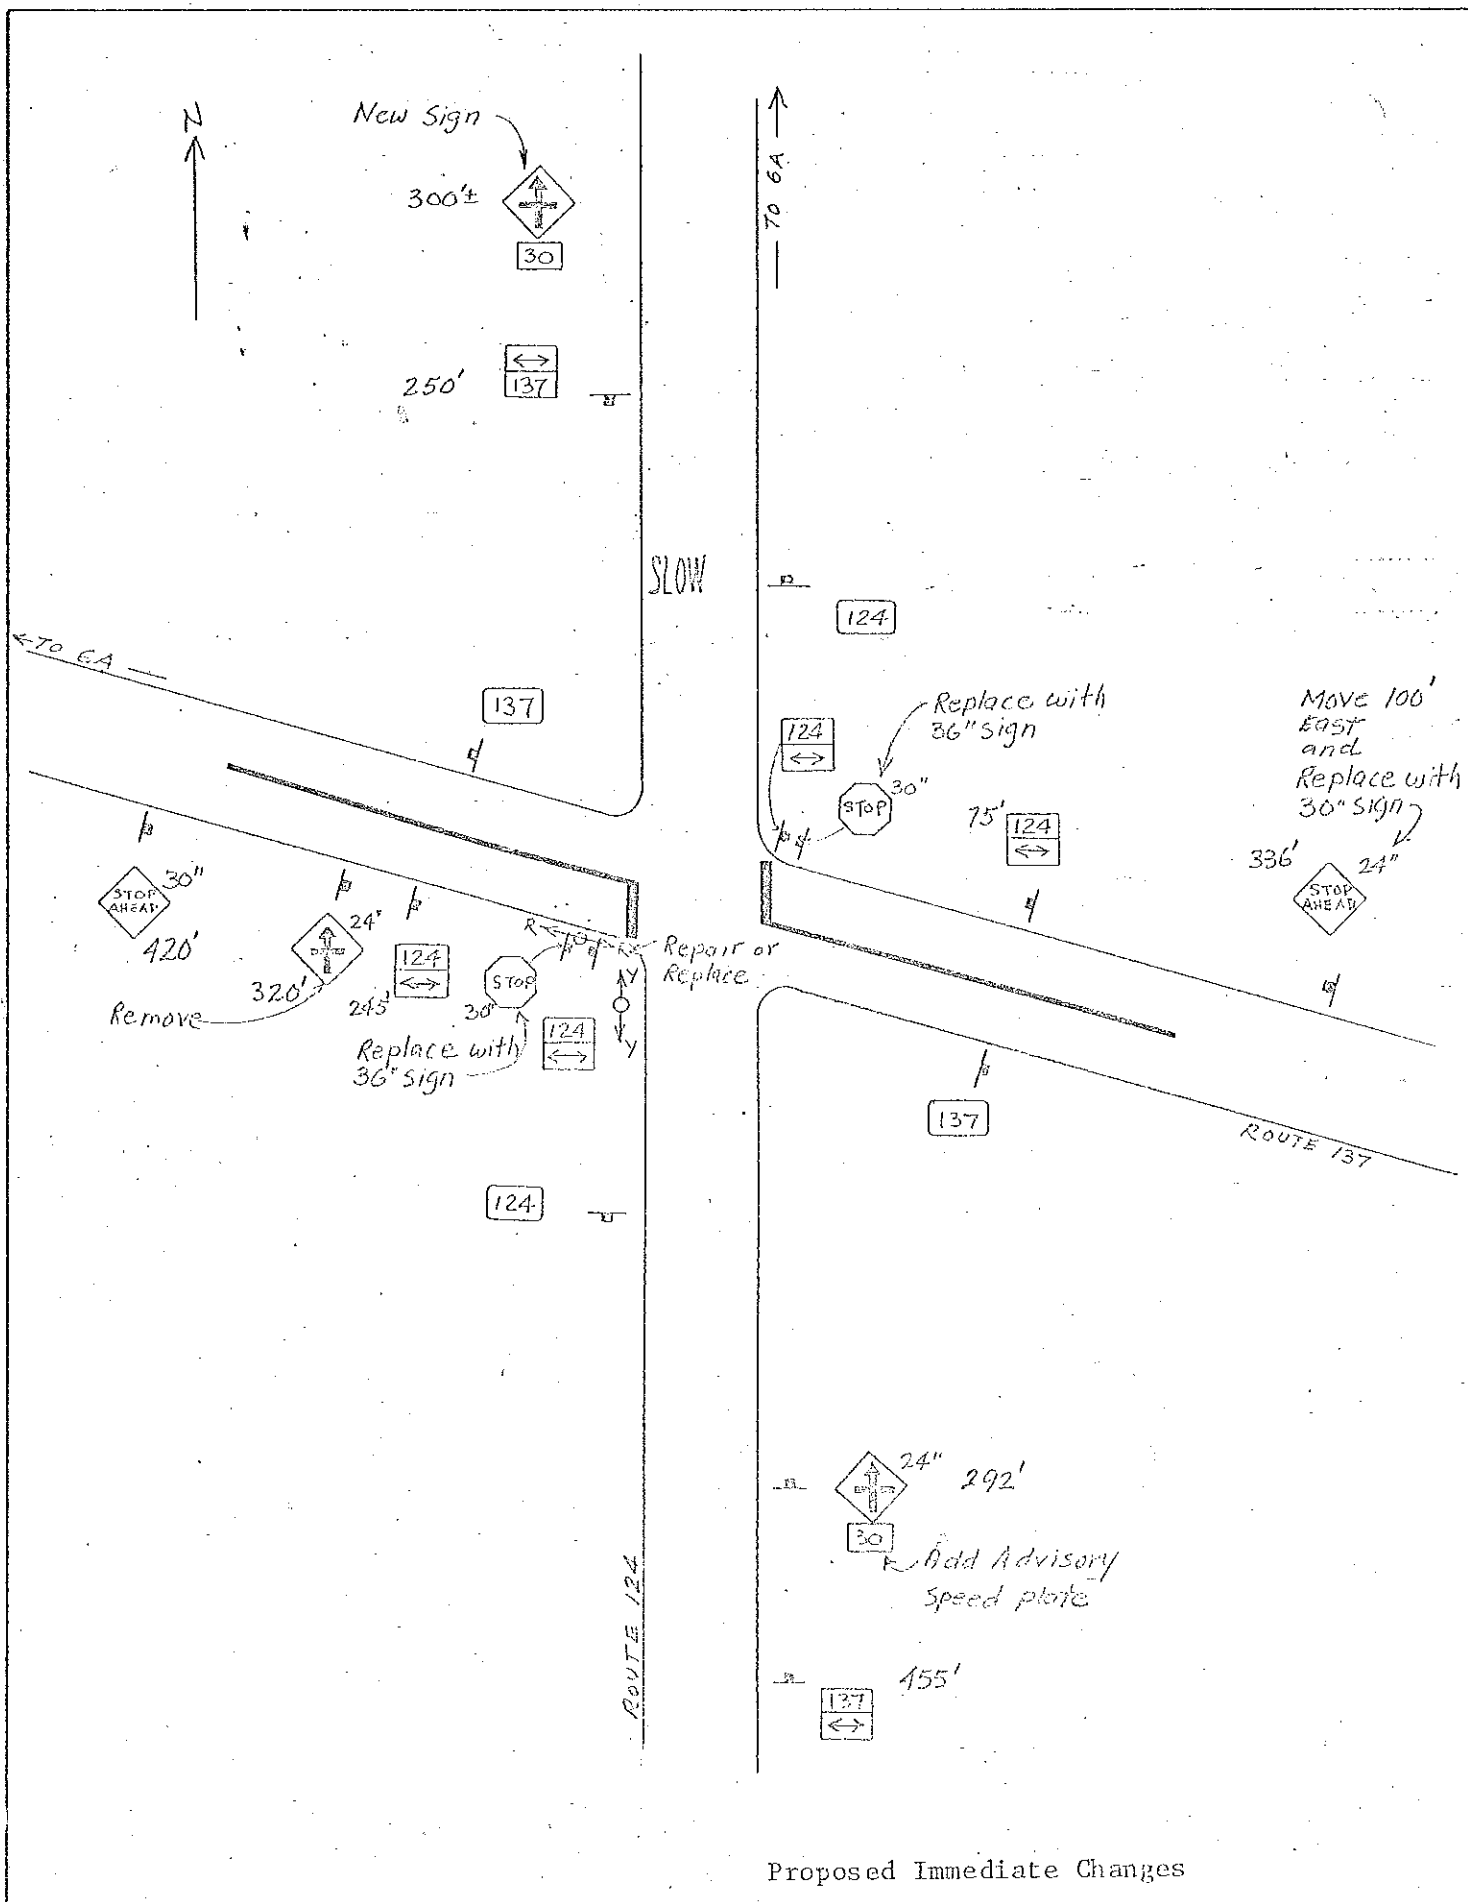
Route 137 and Route 124, Brewster

Until signals are installed, some work is needed immediately. The first step would be to replace both 30 inch STOP signs with 36 inch panels. The 24 inch STOP AHEAD sign in the westbound direction on Route 137 should be replaced by a new 30 inch panel and moved about 100 feet further away from the intersection. A solid white 12 inch stop line should be painted on both Route 137 approaches using permanent type reflective material. These stop lines should be relocated forward of the existing stop lines so that stopped drivers can see approaching traffic before starting up again. Figure 14 shows proposed immediate improvements.

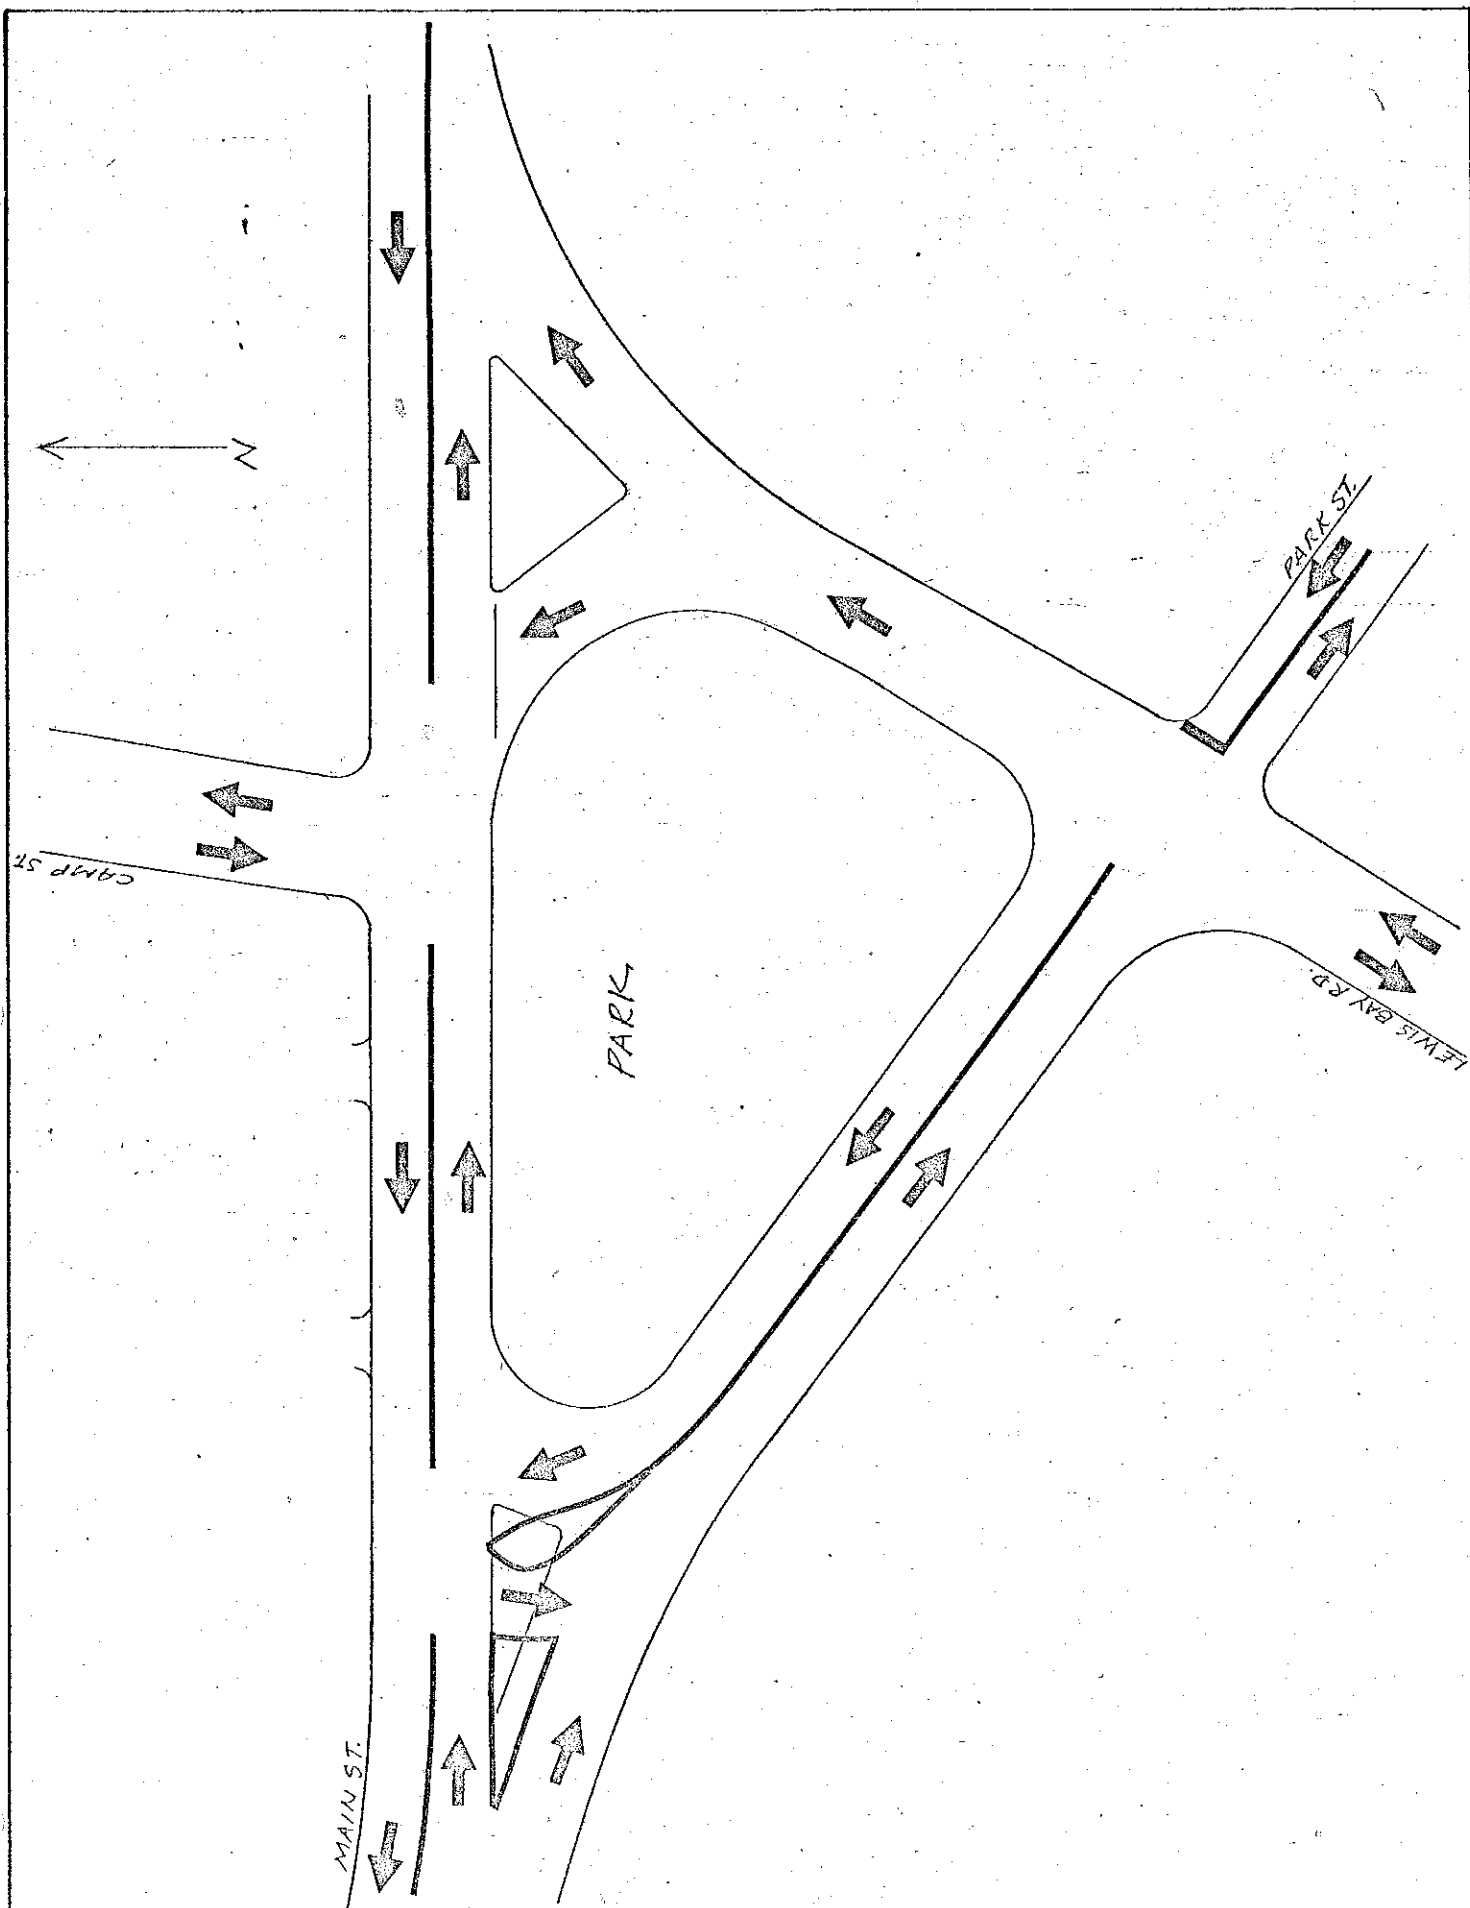
Park Square, Barnstable

Figure 23 shows a proposed traffic pattern for peak seasonal conditions. In this plan, Park Street would become two way between Main Street and Lewis Bay Road. This arrangement would allow traffic from Lewis Bay Road to turn left on Park Street westbound. Main Street eastbound traffic would now continue straight on Main Street rather than make the loop around the park. Eastbound traffic on Main Street headed toward Lewis Bay Road and Park Street would continue to use Park Street. The left turn from Main Street to Park Street would still be permitted. Lewis Bay Road between Park Street and Main Street would continue to be one way for eastbound traffic (a heavy volume) and for traffic headed toward Camp Street. The latter is a moderate volume and probably can be made without police control except during unusually high peak periods.
